Quantum Scalar i6000

Release Notes

Product	Scalar® i6000, Firmware Version i12.4.8.2
Firmware Version	745Q.GS00200
Operating Systems (Standalone LMC Client)	Microsoft Windows Ubuntu x86/ia64 Red Hat Linux x86/ia64
Supported Web Browsers (Java GUI)	Firefox Internet Explorer versions 7 and higher
Supported Web Browsers (WebGUI)	Firefox Chrome
Required Java Runtime Environment (JRE)	JRE version 6 (1.6) and higher
Date	September 2017

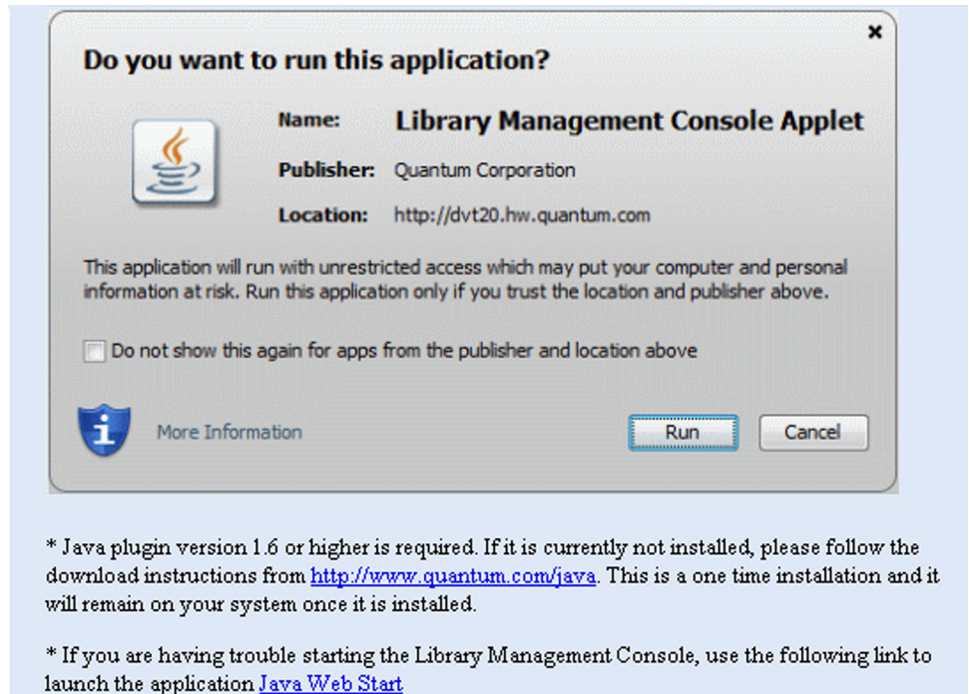
- 1 In your browser, type the IP address or Library name in the address field and press **Return**. The following screen displays.

- 2 At the bottom of the screen, click the **Java Web Start** link. Your browser will download and launch an application that will allow you to use the remote GUI.
