## QXS 6G Gx222xxxx Release Notes

| Product | The Gx222xxxx firmware includes the following versions: |

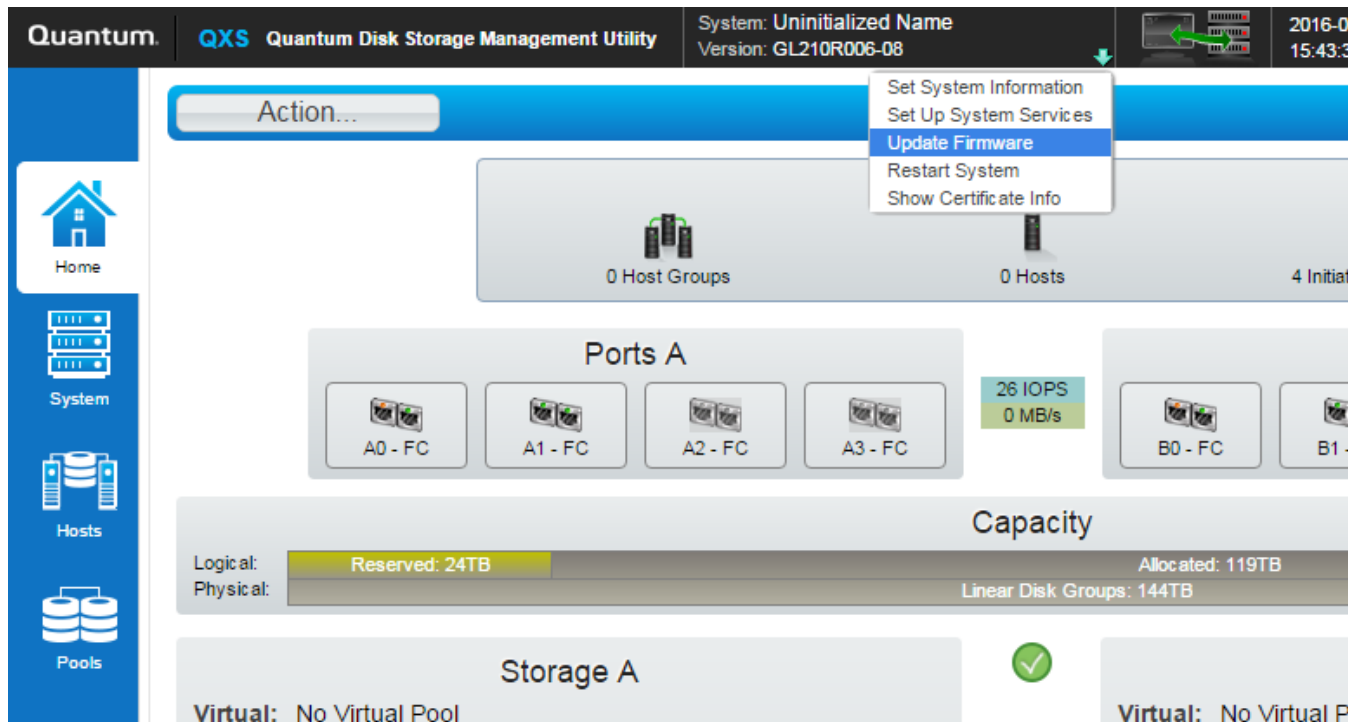
Figure 3 Sample Home Screen

- 1 Obtain the firmware package, and save it to a temporary directory. This firmware release can be obtained by contacting Quantum Technical Support.
- 2 Locate the firmware file in the downloaded/extracted folder. The firmware filename is in the following format: GxxxRyyy-zz.bin.
- 3 In single-domain environments, stop all I/O to vdisks in the enclosure before starting the firmware update.
- 4 Log in to Disk Storage Management Utility.
- 5 Go to the Update Firmware option. There are two ways to do this:
  - a On the top of the home screen ([Figure 3](#)), click the first arrow on the upper right where the System name and Version are shown. Click Update Firmware.

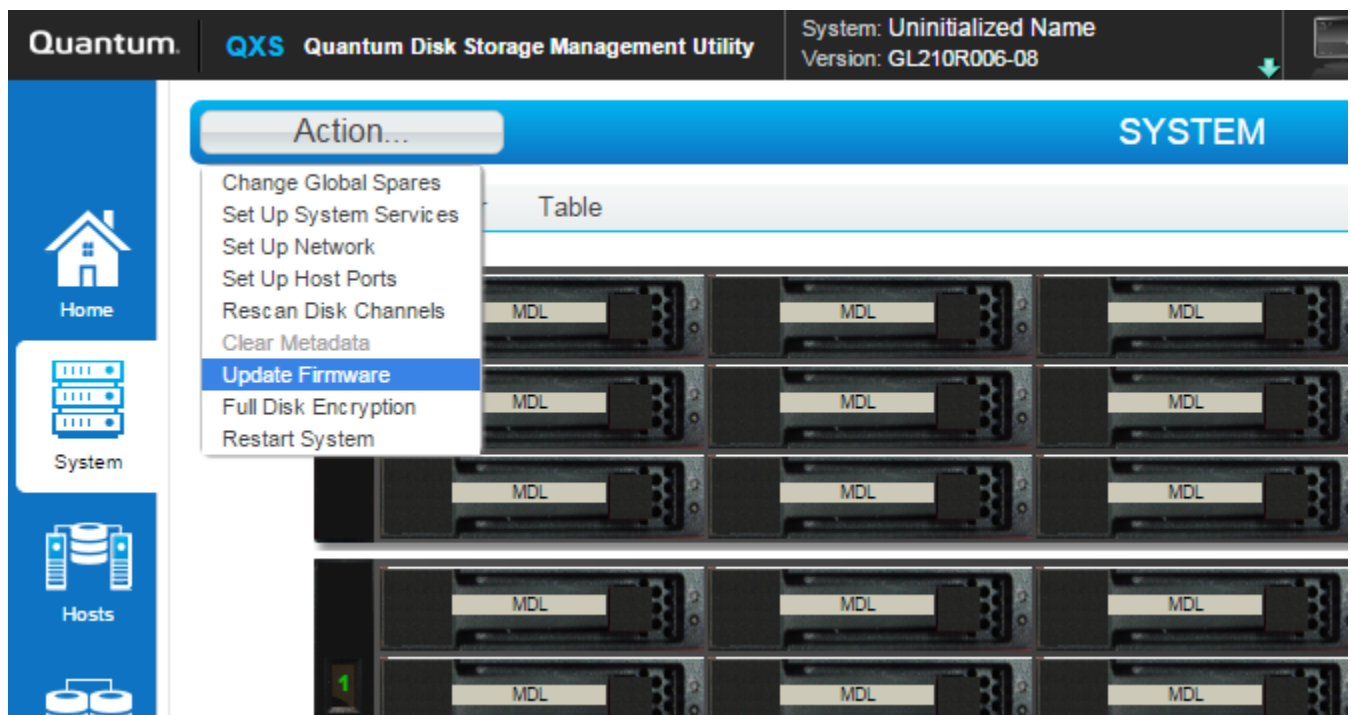
Figure 4 Sample System Screen

- b Click the System tab on the left navigation panel (Figure 4), click the Action button at the top of the system panel, and click Update Firmware.

**Note:** With either of these methods, the panel displayed contains a table that shows the currently installed firmware versions.
