## QXS 12G System Release Notes

GT280R010-01 firmware supports the following Quantum QXS 12G systems:

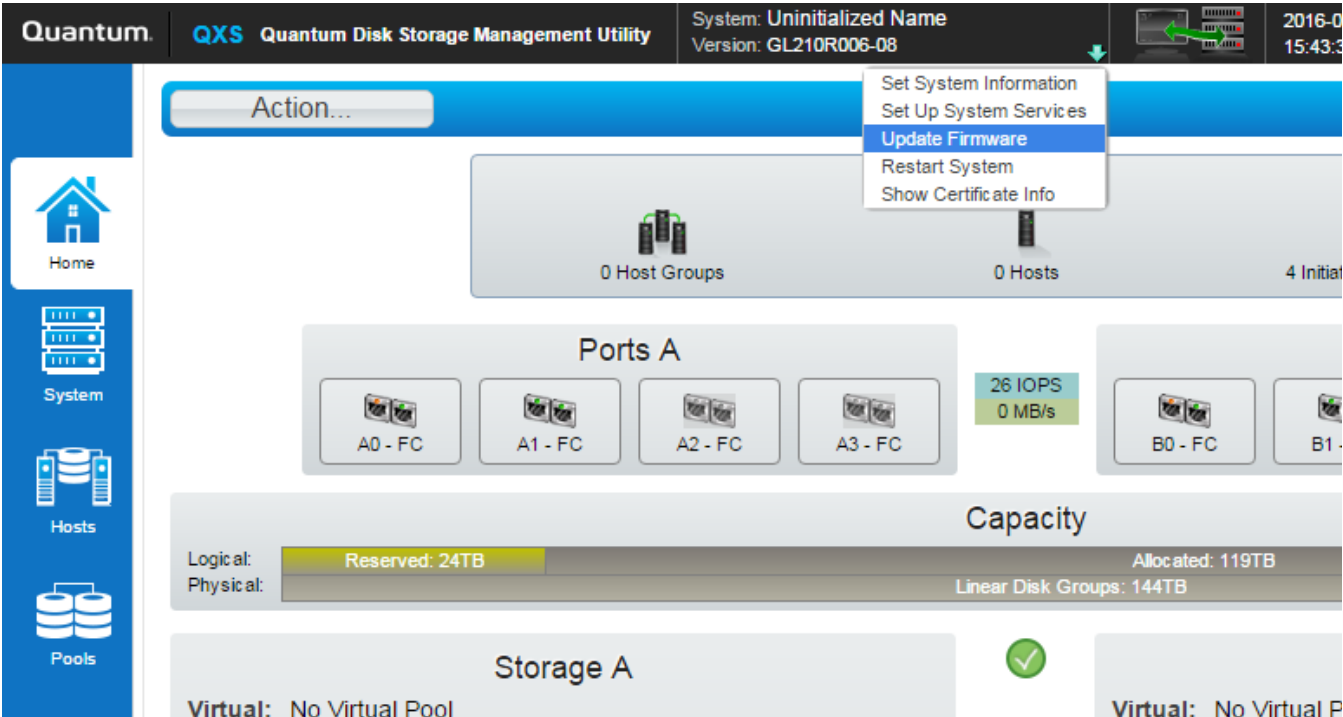
Figure 1 Sample Home Screen

- 1 Obtain the firmware package from [https://www.quantum.com/en/service-support/downloads-and-firmware/qxs-3-4\\_g2\\_12g/](https://www.quantum.com/en/service-support/downloads-and-firmware/qxs-3-4_g2_12g/) (you will need to enter a valid Quantum serial number for your QXS array), and save it to a temporary directory.
- 2 Locate the firmware file in the downloaded/extracted folder. The firmware filename is in the following format: GxxxRyyy-zz.bin.
- 3 In single-domain environments, stop all I/O to vdisks in the chassis before starting the firmware update.
- 4 Log in to Disk Storage Management Utility.
- 5 Go to the Update Firmware option. There are two ways to do this:
  - a On the top of the home screen ([Figure 1](#)), click the first arrow on the upper right where the System name and Version are shown. Click Update Firmware.

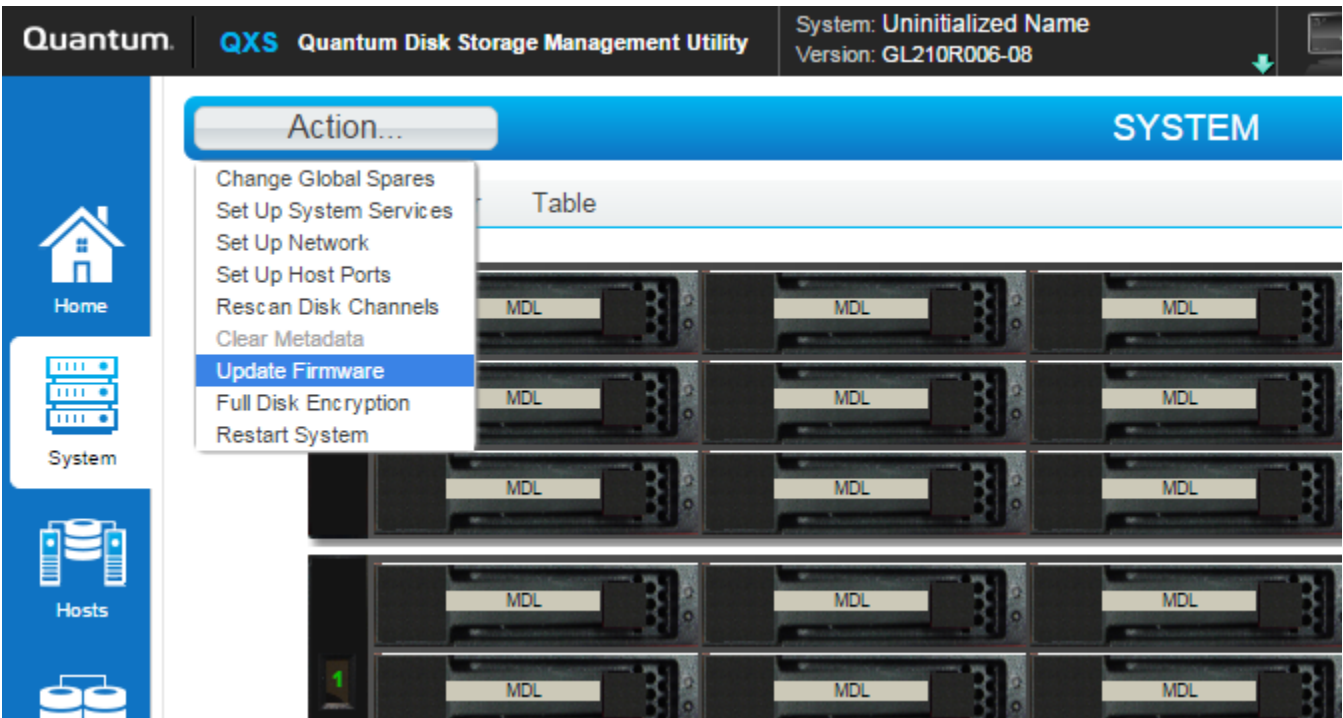
Figure 2 Sample System Screen

- b Click the System tab on the left navigation panel (Figure 2), click the Action button at the top of the system panel, and click Update Firmware.
