## QXS Gx222xxxx Release Notes

| Product | The Gx222xxxx firmware includes the following versions: |

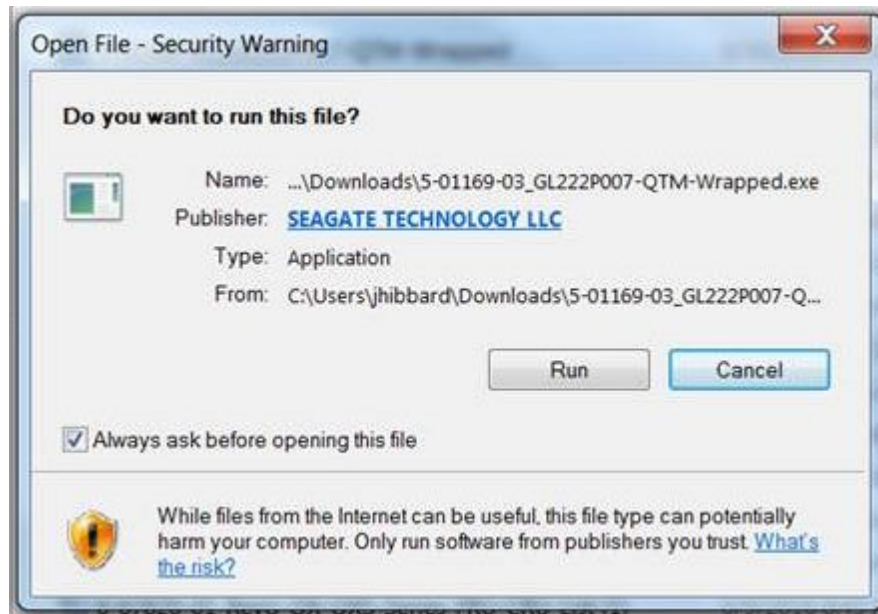
Figure 1 Security Warning  
Pop-Up

Refer to [Figure 2](#) for a representative example of the security warning pop-up.
